# TEST REPORT

**NAME OF SAMPLE** : Power House

**TEST ITEM** : Impact test

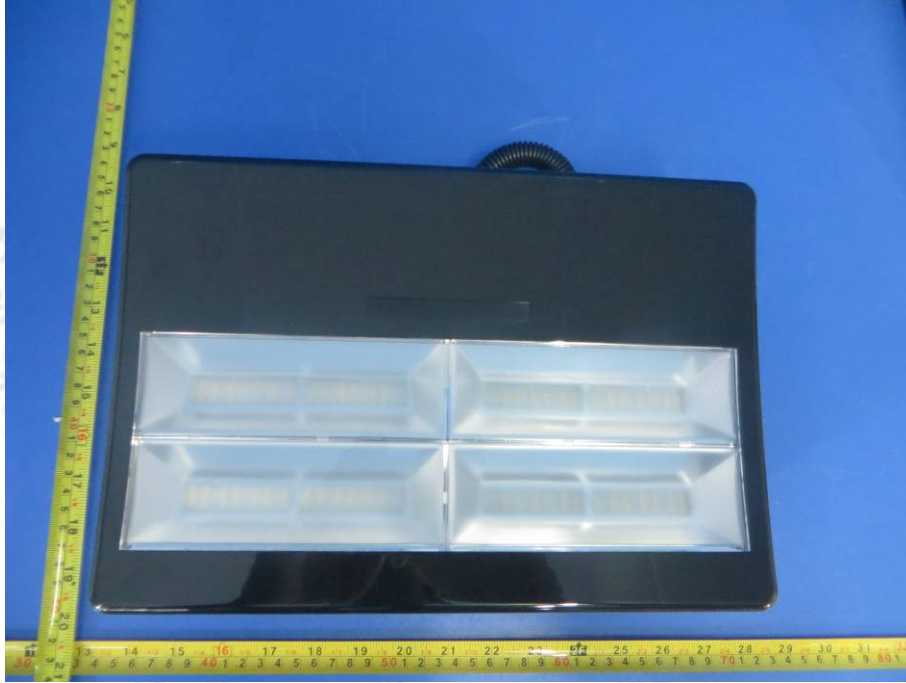
Fig. 1 Product Picture

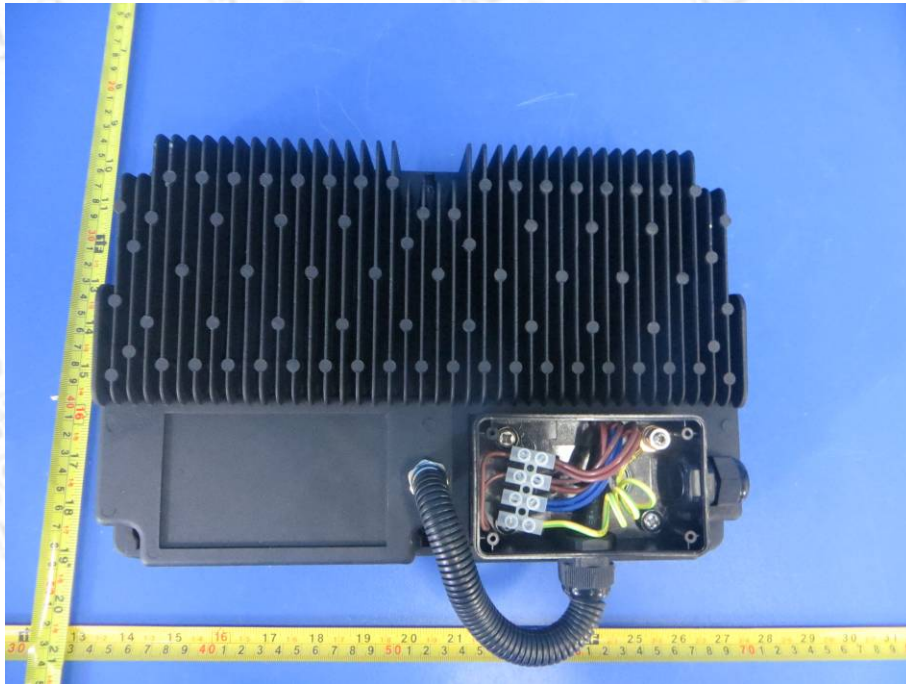
Fig. 2 Product Picture

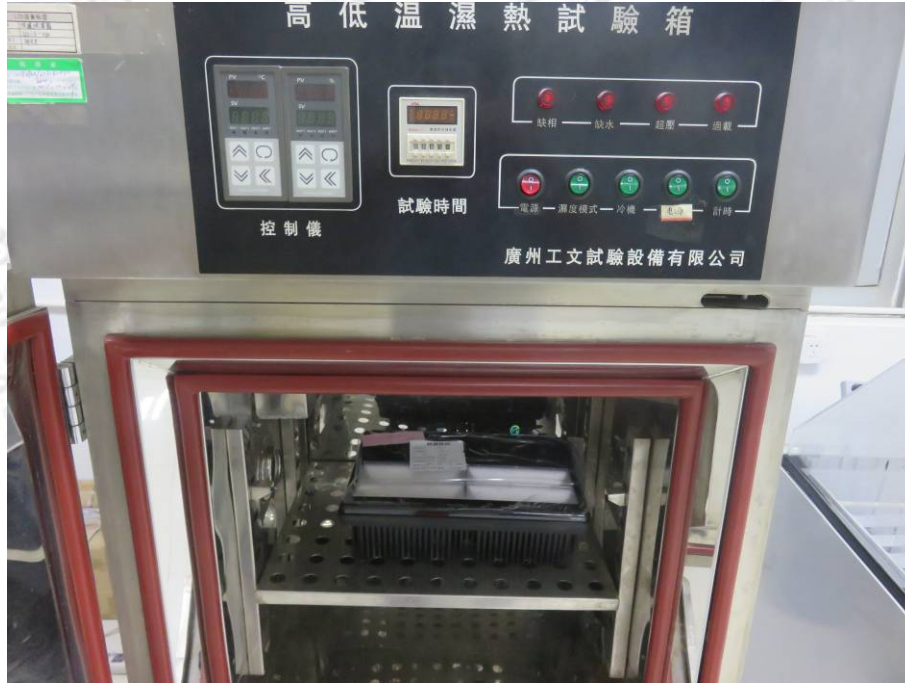
Fig. 3 The Impact Test

Item	Test Item	Standard Requirement	Result
1	Impact test	<ol style="list-style-type: none"><li>1. The test sample appearance in good condition</li><li>2. The high temperature test + 80 °C for 1 hour</li><li>3. - 40 °C low temperature test for 1 hour</li><li>4. Repeat the above steps 3 and 4 four times</li><li>5. After the completion of the test check whether the sample appearance in good condition, with or without deformation</li></ol>	Appearance in good condition, the performance is normal, invisible

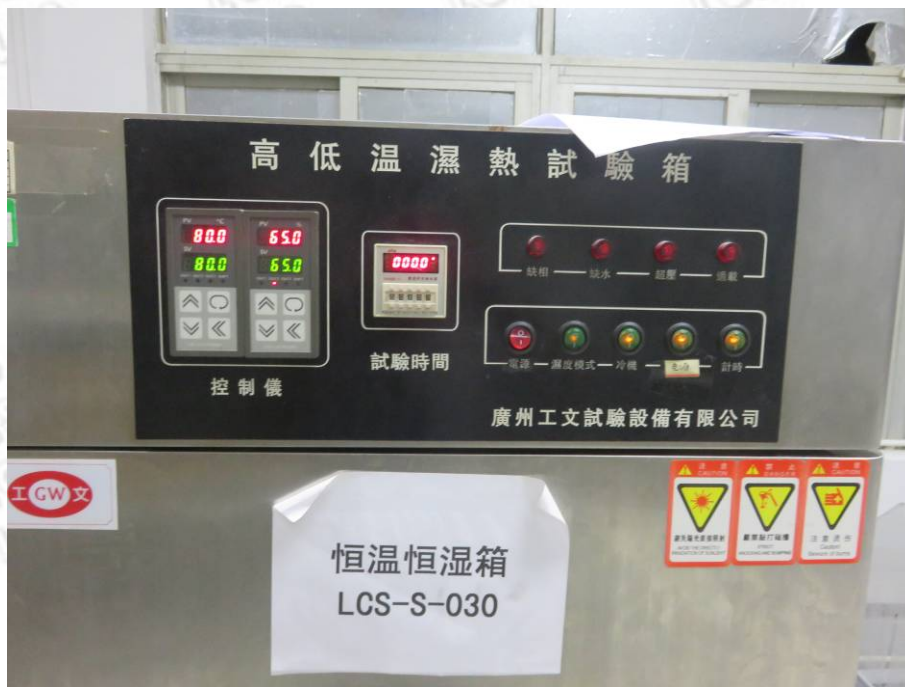
Fig. 4 The Impact Test

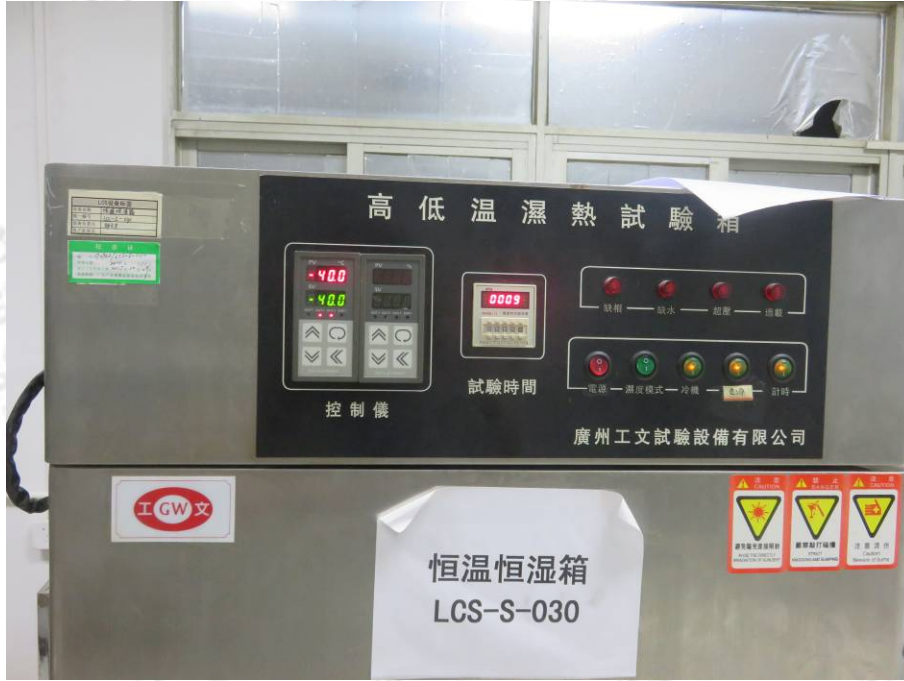
Fig. 5 The Impact Test

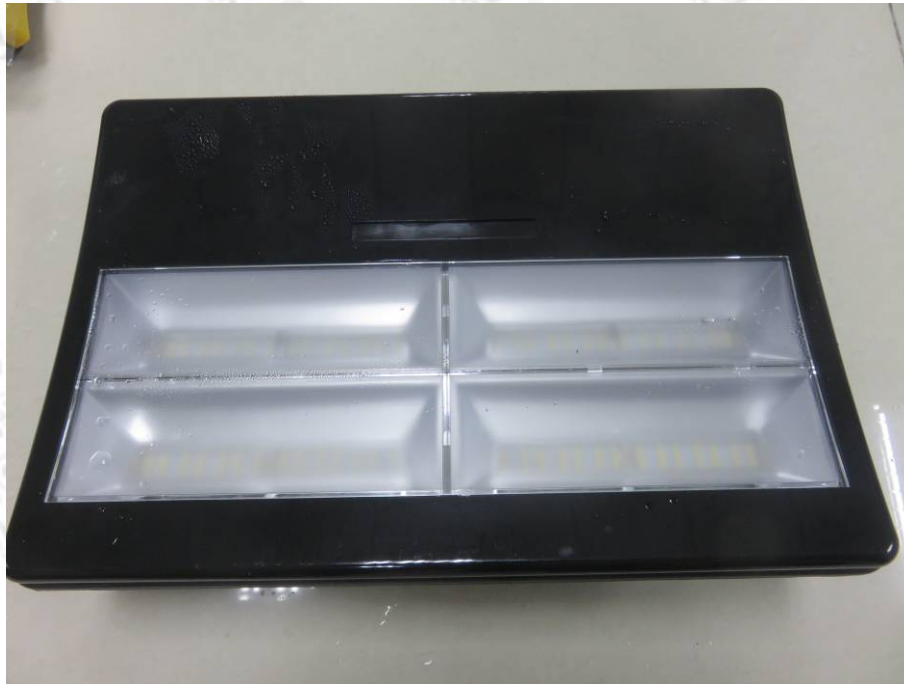
Fig. 6 After The Impact Test
